# VACS system reduced operational risk in debris-filled long lateral

An operator in Lea County, New Mexico, identified several 2nd Bone Springs wells as candidates for restimulation and needed a way to remove debris from the lateral section of the well.

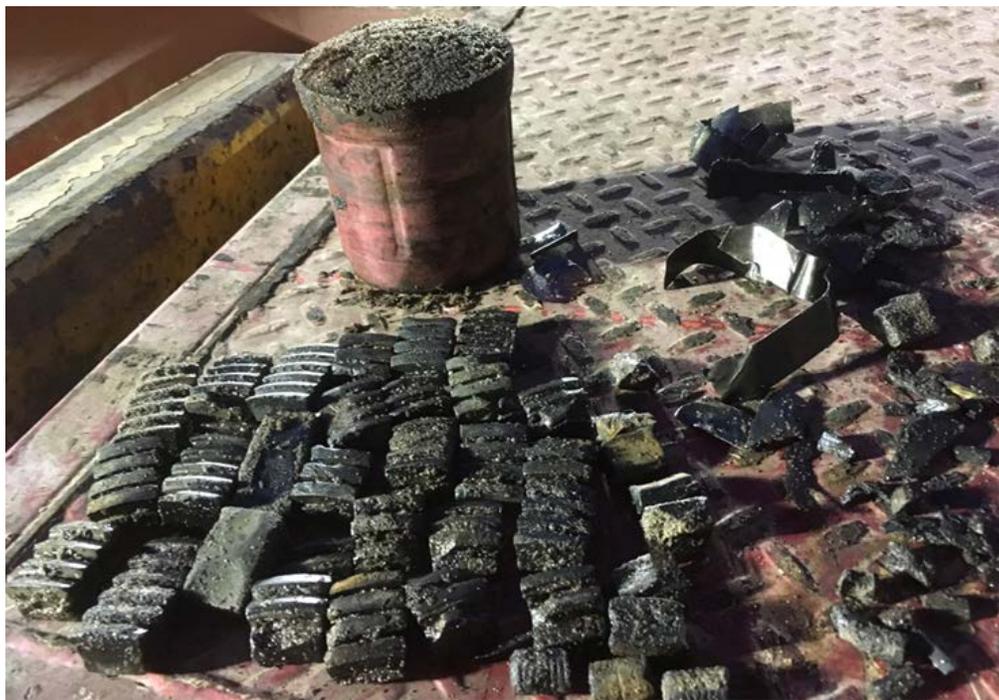
Eight joints of tubing filled with sand, 28 cast iron slips, two ESP monel bands, and a handful of miscellaneous plug parts were recovered in just one trip.

During VACS operations, the wellbore was washed down from 8,860 ft to 13,420 ft (2701 m to 4090 m) through the lateral. A total of 37 joints of 2 7/8-in. tubing filled with sand were recovered. This equated to 264 ft (80 m) of completely lost 5.50-in. 17 lbs/ft production casing. A total of 36 slips and miscellaneous plug parts were recovered that had been in the well since the initial stimulation in 2012. Five monel bands were also recovered that were lost
